SERVICE BULLETIN 1

BLISTERING OF FUEL MANIFOLD HOSE OUTER COVER

Cameron Balloons U S
7399 Newman Boulevard
Dexter, MI 48130

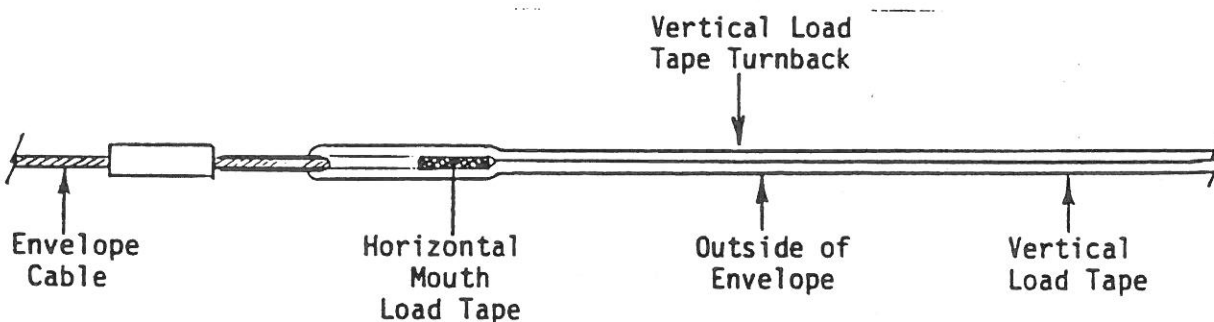
Figure 1. INCORRECTLY INSTALLED MOUTH LOAD TAPE

Several balloons constructed between March 31, 1986, and June 10, 1986, may have horizontal mouth tapes which were incorrectly installed. This incorrect assembly could result in eventual damage to the stitching of the vertical load tapes at their joints with the mouth cables with possible significant reduction of the strength of this joint. This bulletin is being provided to you since your balloon may have this condition.

In several balloons, the mouth horizontal load tape may be incorrectly sewn sandwiched BETWEEN the two parts of the vertical load tape. The sketch below shows a side view of this INCORRECT assembly of the horizontal mouth load tape relative to the vertical load tapes:

Within the next 10 flight hours on the balloon, or before July 15, whichever comes first, inspect the mouth of the balloon to determine if the mouth horizontal load tape has been incorrectly installed. The sketch below is a side view showing the CORRECT assembly of the load bearing tapes at the mouth of a Cameron balloon.

1. If the horizontal load tape at the mouth on your balloon has been INCORRECTLY installed please advise us by phone or mail. We will schedule a time when we can correct the assembly of these tapes. Cameron Balloons U S will make this correction at no charge to you and will pay the cost of shipping the envelope both ways. Do NOT ship your envelope without first contacting us.

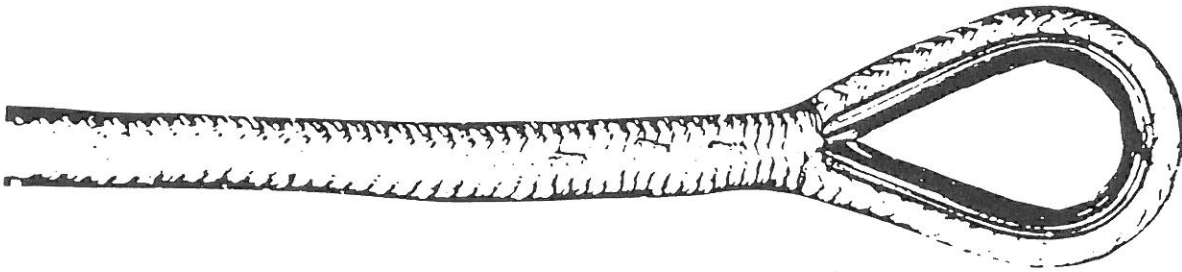
Stitched: OK

IF the eye splice is either stitched or whipped as shown in the photos labelled "Stitched: OK" or "Whipped: OK" on the attached sheet, THEN the inflation harness line is NOT from the suspect batch. In this case CHECK the "STITCHED" or "WHIPPED" box as appropriate on the enclosed Postal Reply Card and mail the card back to us. You may continue enjoying the benefits of using your current inflation harness rope.

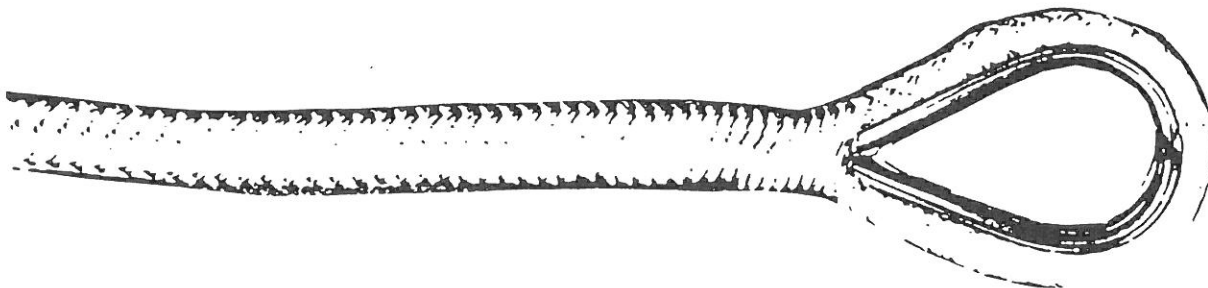
Neither Sticked nor Whipped: SUSPECT (Return for Replacement)

The eye splices in a number of inflation harness ropes (Cameron p.n. B114) delivered since January 23, 1987, have been found to have been incorrectly made. Our records show that you probably were shipped one of the inflation harness ropes from the same batch from which these known incorrectly-spliced ropes came.

The possible defect in your inflation harness rope could cause the eye splice to work loose, possibly causing the eye splice to separate and allow the balloon suddenly and unexpectedly to break free of its inflation line mooring.

IF the eye splice is neither stitched nor whipped as shown in the photos or looks like the photo labelled "Neither stitched nor Whipped: Suspect," THEN the inflation harness rope IS from the suspect batch. In this case DO NOT use the inflation harness rope again. RETURN the harness line to us for replacement with a new line.

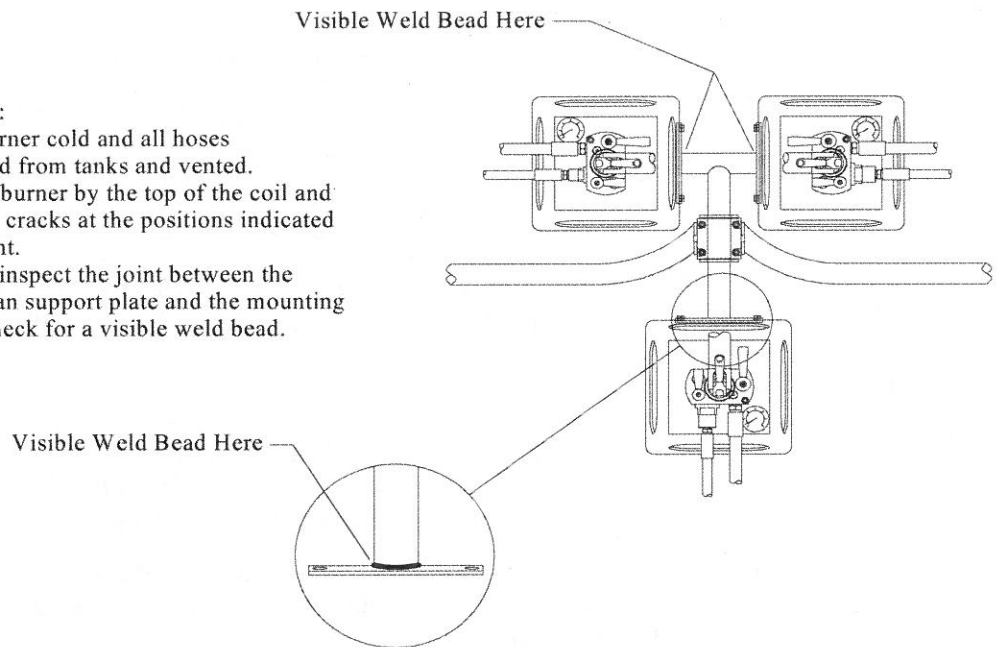
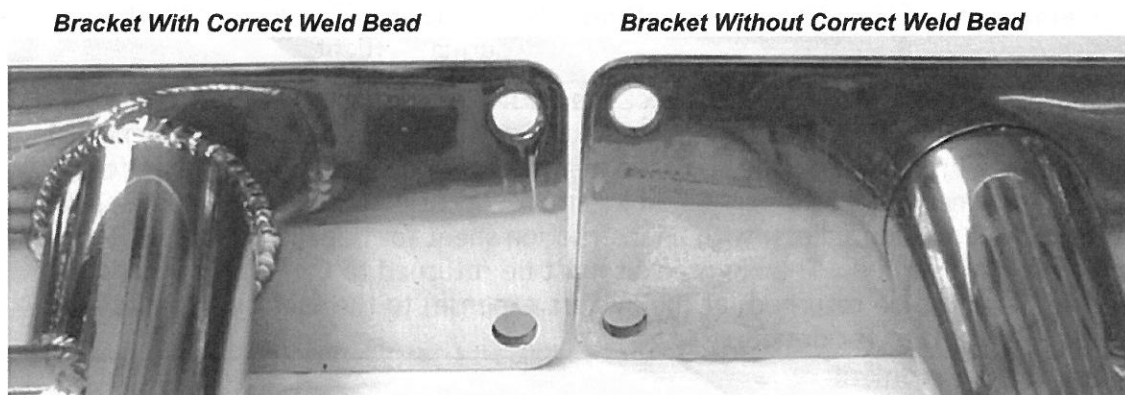
7. Figure 1:

(a) No.:	5	
(b) Revision / Date	Revision 0 / Date: February 07, 2005	
(b)Title:	Cracking of a Weld on Gimbal Block Framed Ultra Triple Burner Mounting Bracket.	
(c)Description:	Possible failure of weld at joint between the burner can support plate and mounting tube.	
(d)Applicability:	All Ultra Triple & Quad Burner assemblies with gimbal block burner frames delivered before October 29, 2004	
(e)Effectivity:	All	
<p>Note: Applicability= All types and variants to which the change can be applied. Effectivity= Actual Serial Numbers to which the bulletin has been applied. See Page 3 of 3 for a complete Burner Serial Number List.</p>		
<p>2. Background: There have been failures during road transport of the weld between the burner can support plate and mounting tube due to insufficient weld bead/fatigue.</p>		
<p>3. Compliance (Category): Inspection before next flight.</p>		
<p>4. Consequences of Non-Compliance (Possible): Burner could become detached during flight.</p>

- 1) Hold the burner by the top of the coil and check for cracks at the positions indicated at the right.
- 2) Visually inspect the joint between the burner can support plate and the mounting tube. Check for a visible weld bead.

<p>5. Accomplishment Instructions: Inspect the burner mounting bracket for cracking. Refer to Page 2 of 3 Figure1. Cracked brackets must be replaced before the next flight. Non-conforming brackets must be replaced at the next Annual/100 Hour Inspection. Bracket replacement MUST be performed by an FAA certified Repair Station or Repair person. Replacement brackets, with an instruction sheet for Repair Stations or Repair Persons, will be provided. The old bracket must be returned to Cameron Balloons U.S. The burner may also be returned (at the owners expense) to the factory. Contact Cameron Balloons U.S. for details.</p>		
<p>6. Materials: Replacement Parts Ultra Quad Bracket - Part Number CB2252. Ultra Triple Bracket - Part Number CB2216.</p>

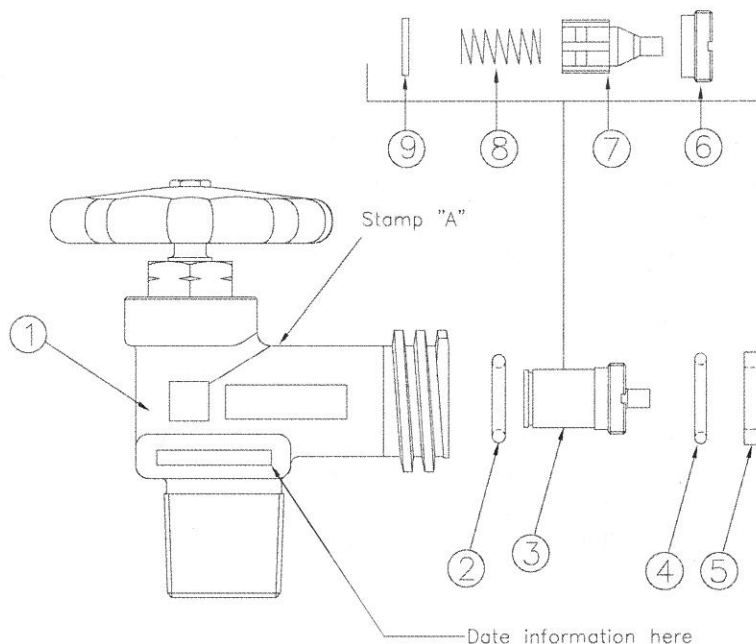
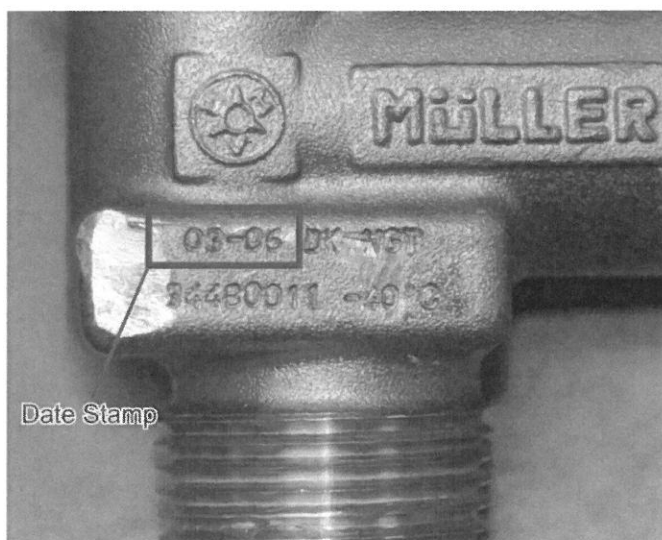
Existing Self Seal Valve replaced by cassette (Item 3)

2. Background: Due to a faulty batch of adhesive, the rubber grommet in the self-seal can become detached from the self-seal stem and block the fuel flow from the cylinder to the burner

7. Additional Information: The valves can also be identified by the word Müller stamped on the valve body and the number 344B0011 stamped under the date stamp (see page 5 of this bulletin).

Procedure: Refer to diagram on page 5.

- 1) Ensure that the liquid valve is in the closed position.
- 2) Remove the outlet gasket (item 5) and outlet outer o-ring (item 4) and discard if damaged.

- 3) Unscrew and remove the self seal retaining ring (item 6). Use special tool part number F825T or equivalent.
- 4) Remove and discard the self seal (item 7), spring (item 8) and washer (item 9).

- 5) Remove and discard the outlet inner o-ring (item 2).
- 6) Fit new inner o-ring (item 2) (supplied with the repair kit).
- 7) Fit self seal cassette (item 3) (supplied with the repair kit) and tighten.

- 8) Fit outer o-ring (item 4) and gasket (item 5) with the supplied replacements.
- 9) Leak check.
- 10) Remove the handwheel (item 10).
- 11) Stamp a 1/4" tall 'A' on the topside of the outlet snout at the base of the bonnet assembly housing.

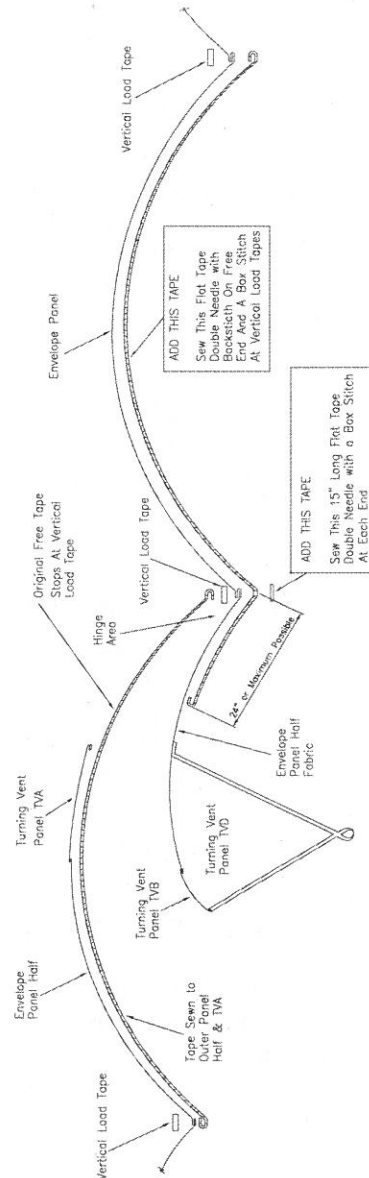
Note: There are two different versions of this style of turning vent. They are illustrated on pages 2 and 3

2. Background: Due to separate changes to engineering design and construction procedures, turning vents on certain models were not reinforced enough to withstand severe conditions

4. Consequences of Non-Compliance (Possible): During aggressive turning vent use in turbulence, and/or snagging during ground handling, it is possible for tears to occur in the fabric adjacent to the hinge

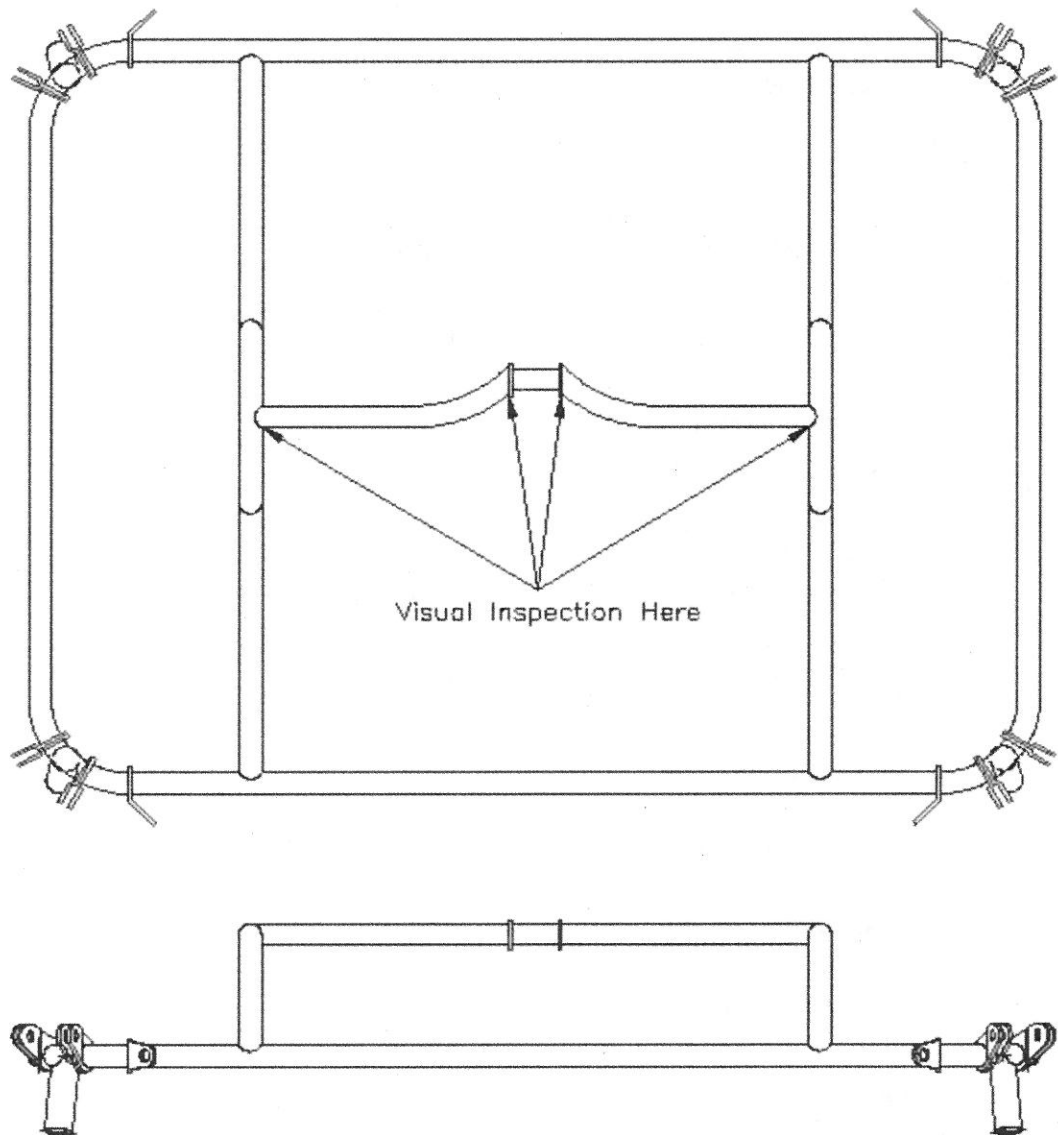
7. Figure 1:

(d) Description: Detailed visual inspection of weld at gimbal bearings (triple burner frame cross bar) and attachment of cross bar to outer frame (triple and quadruple burner frames) See Figure 1

2. **Background:** There have been weld cracking and failures during road transport of the weld at the gimbal bearing (triple burner frame cross bar) and attachment of the cross bar to outer frame (triple and quadruple gimbal block burner frames). See Figure 1.

4. **Consequences of Non-Compliance (Possible):** Burner could become detached from the frame during ground transport.

1. Visual Inspection (see Figure 1) through 360° at weld around gimbal bearing (triple burners only) and at attachment of cross bar to bridges on outer frame (triple and quadruple burners). This may be carried out by the owner/operator.
2. Remove from service any frame showing signs of cracking.
3. Report any rejections to Cameron Balloons US.
4. Cracked frames can be returned to service by following the instructions obtained from Cameron Balloons U.S.

If cracks in any of the welds are found, follow the instructions and processes below. It is highly recommended that the bracing tubes be installed whether cracks are found or not.

1. Remove the Burner Assembly from the Frame
2. Weld the identified affected areas where cracks are found per the processes on pages 4 or 5. The braces must be notched to fit on each end prior to welding.

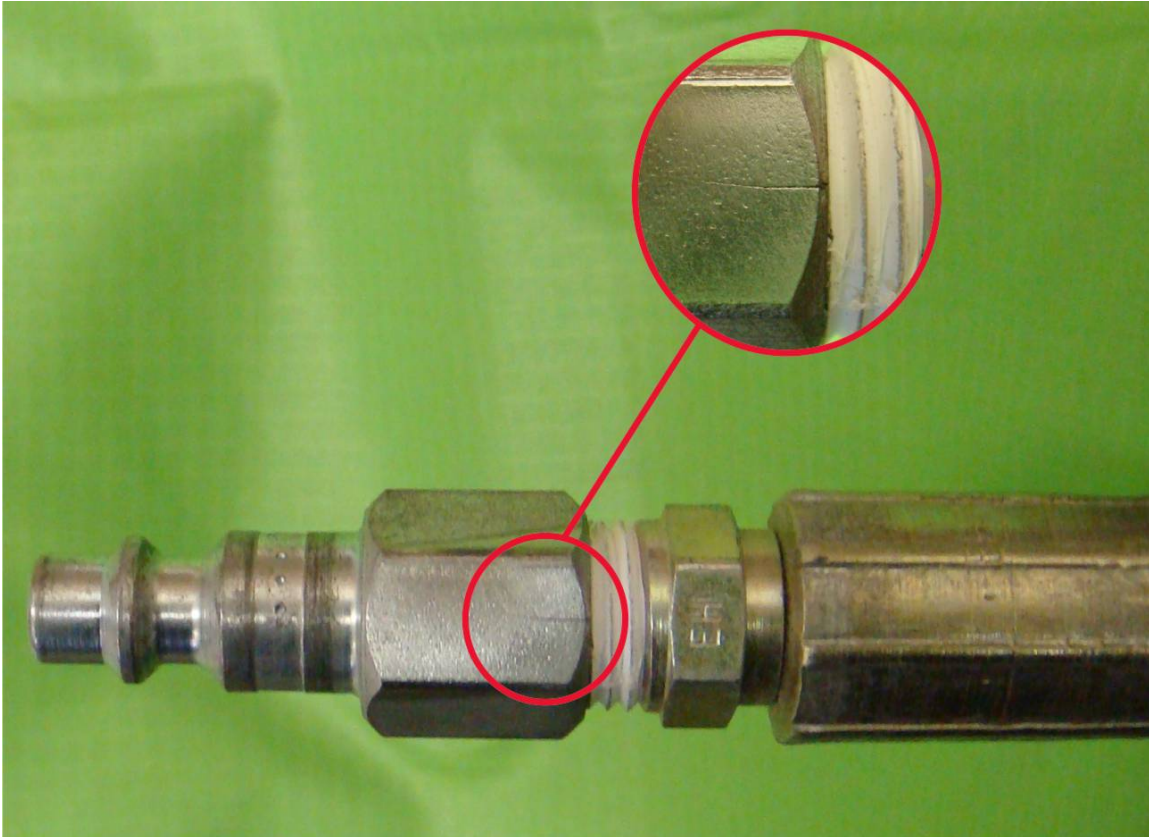
(a) No.:	9
(b) Revision / Date	Revision 0 / Date: May 12, 2009
(c) Title:	Vapor Pilot Light Hose Male Quick Connect Fitting Cracks
(d) Description:	A crack in the Vapor Pilot Light Hose Male Quick Connect Fitting

(e) Applicability:	Vapor Pilot Light Hoses delivered between February 2002 & April 2008
(f) Affectivity:	All Vapor Pilot Light Hoses
2. Background:	It has been found that several Vapor Pilot Light Hose Male Quick Connect Fittings may have a visible crack in the hex section of the fitting (see the picture below). There have been no leaks due to this condition due largely to the Teflon tape seal and the very low pressure at this fitting.

5. Accomplishment Instructions: Inspect both visually and with a gas leak detector (with the hose under pressure) the Vapor Pilot Light Hose Male Quick Connect Fitting for a crack in the hex section.

6. Materials:	If a crack is found, a new Male Quick Connect Fitting will be supplied free of charge. Contact Cameron Balloons US for a replacement.
7. Instructions:	Remove the damaged Male Quick Connect Fitting with a suitable wrench. Remove any Teflon tape residue from the threads on the hose end. Apply new Teflon tape to the hose end. Install the new Male Quick Connect Fitting on the hose. Take care to not over-tighten. The hose end is a male tapered pipe thread and acts a wedge. Over-tightening will split the fitting and cause a crack.
