Cameron Balloons US Service Bulletin 11

1	General	
(a)	Number	11
(b)	Revision / Date	0 / 1 JUN, 2025
(c)	Title	PRV Adaptor CB8426 for Legacy Fuel Tanks (Cylinders)
(d)	Description	Inspection and possible replacement of adaptors in service based on pass criteria.

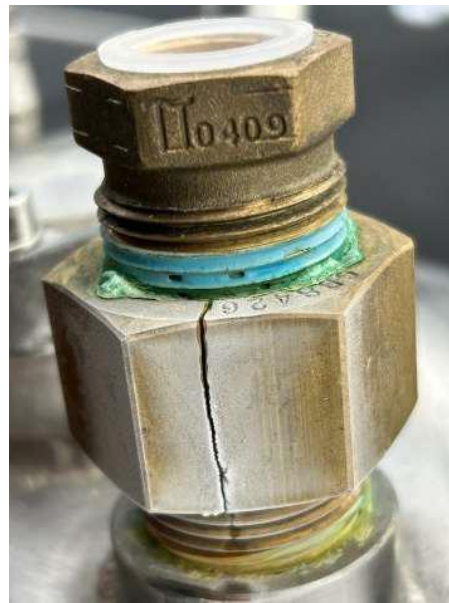
Failed components have presented with a crack located on the upper hex portion of the adaptor (see figure 2).

Figure 2
Cracked CB8426, PRV Adaptor

3	Compliance (Category) Required on receipt of this bulletin.
4	Consequences of Non-Compliance (Possible) Uncontrolled leak of LPG fuel.
5	Accomplishment Instructions Affected PRV adaptors installed in fuel tanks (cylinders) must be visually inspected for cracks within 24 hours of receipt of this bulletin. Any fuel tanks found to have cracked adaptors installed should be emptied of fuel immediately. Contact Cameron Balloons US in the event of the discovery of a cracked adapter. Affected PRV adaptors found without cracks can continue to be used for flight but must be inspected before each flight. Adapters supplied by CBUS that do not have the "CB8426" stamp do not need to be further inspected. These instructions can be performed by the pilot/owner.
6	Materials: None
7	Other Publications Affected: None
8	Mass (Weight)/Balance: Not affected
9	Maintenance and Operating Instructions: Not affected
10	Additional Information: For any questions concerning the technical content of the requirements in this Service Bulletin, please contact: <div style="text-align: center;">Cameron Balloons US 7399 Newman Blvd Dexter, MI 48130 email: tech@cameronballoons.com Phone: +1 734 426 5525</div>

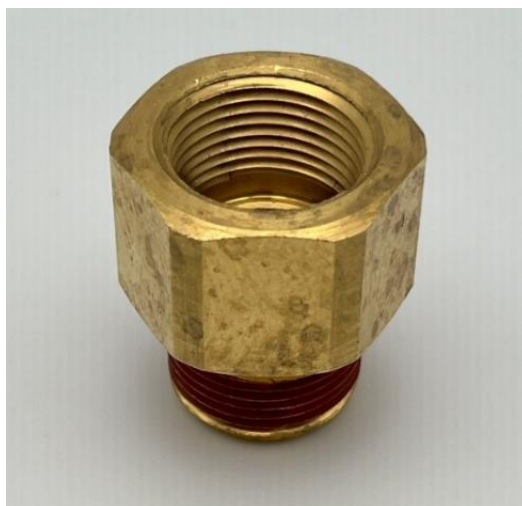
Figure 3
Non-affected F8426 (not stamped with "CB8426")
