SERVICE BULLETIN 1

BLISTERING OF FUEL MANIFOLD HOSE OUTER COVER

Cameron Balloons U S
7399 Newman Boulevard
Dexter, MI 48130

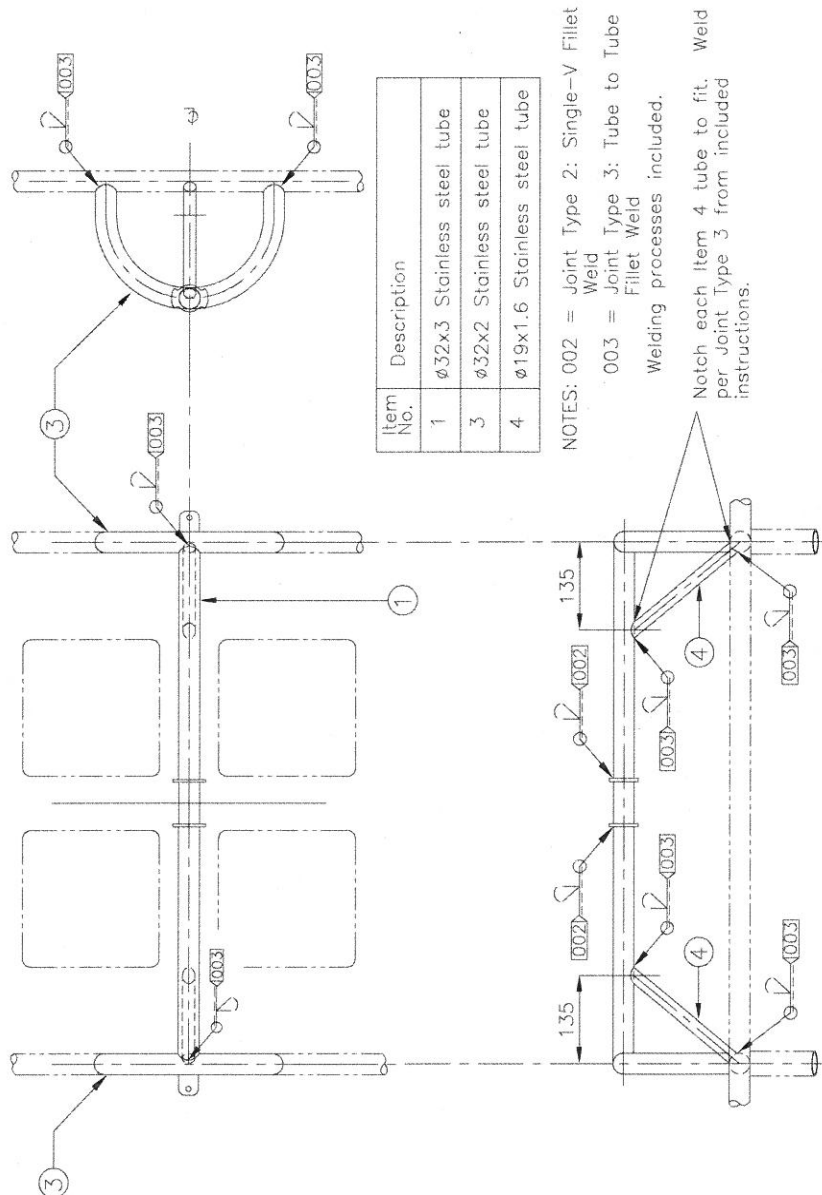
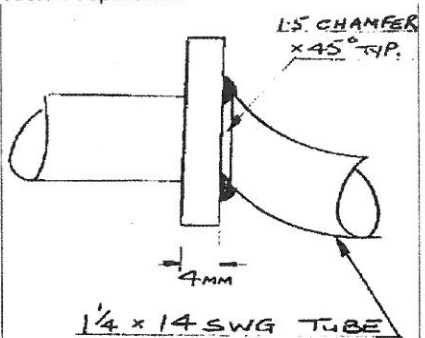
(c) Title: Triple and Quadruple Gimbal Block Burner Frames - Weld Inspection

4. **Consequences of Non-Compliance (Possible):** Burner could become detached from the frame during ground transport.

If cracks in any of the welds are found, follow the instructions and processes below. It is highly recommended that the bracing tubes be installed whether cracks are found or not.

1. Remove the Burner Assembly from the Frame
2. Weld the identified affected areas where cracks are found per the processes on pages 4 or 5. The braces must be notched to fit on each end prior to welding.

CAMERON BALLOONS		Welding Procedure		No./Rev.: 02/A	
Location shop / site CB Eng.				Date: 05/11/97	
RANGE OF APPROVAL				Address: CBL	
Welding process(es) GTAW (TIG)	Single pass/Multipass Multipass				
Joint type 2. Single-V Fillet	Parent Metal Groups Austenitic st. steels				
Plate thickness Range 4mm	Tube O/D Range 1 1/4" x 14SWG				
Type of Welding Current	Heat Treatment None				
CONSUMABLES					
Filler Material 347Si	AWS/ASME Spec. SFA-5.9 - 95 ER347Si				
Diameter 0.8 / 1.6	Type CHROMATIG 347	Weld Preparation

Tungsten 1.6 Dia. 2% Ceriated	Nozzle Dia. 8mm				
Gas Composition BOC Pureshield P1	Gas Flow Rate 8 litres per min.				
Preheat and interpass temperature(method) and control					
Postweld heat treatment temperature(method) and control					
Notes Triple Burner Gimbal arm assembly.					
Procedure Detail					
Op.	Process	Current	Polarity

1.	Ensure all items are free from dirt grease and moisture.		-Ve		
2.	Tack in 4 positions.				
3.	Complete root run using 0.8 mm filler wire				
4.	Complete cap run using 1.6 mm filler wire Note: Only stainless steel brushes to be used				
Approval					
Date		Name		Signature
